Cannabis Farms – A Growing Problem

CILA Property Special Interest Group

September 2019

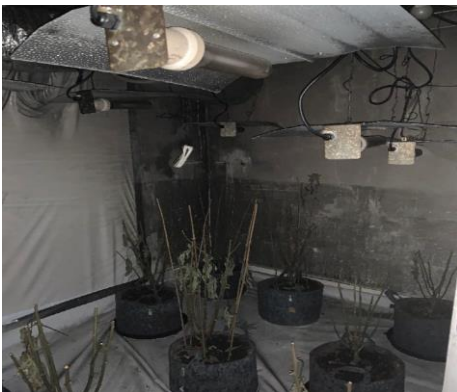
Cannabis plants on first floor

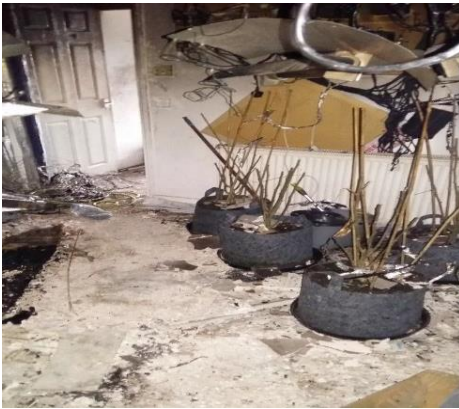
Cannabis plants and equipment on ground floor

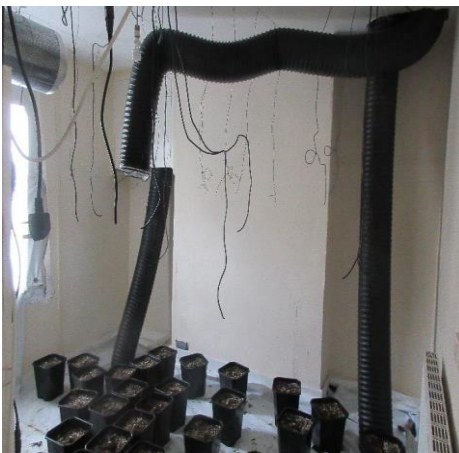
Installation of cannabis cultivation equipment

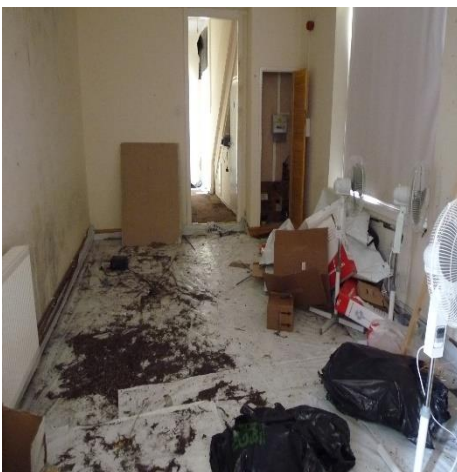
Condensation has resulted in significant spoiling of decorations

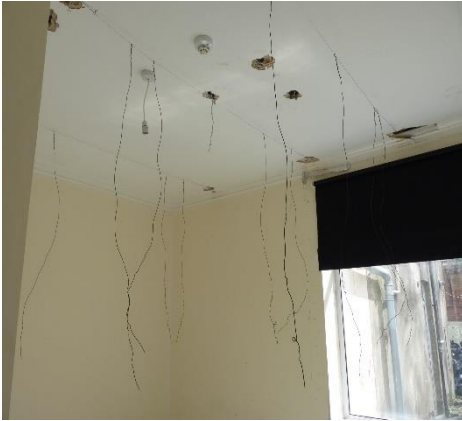
Holes made in ceilings to locate rafters for lamp fixings

- Physical damage had been sustained to the building including escape of water from a bath, electrical supply being altered, internal fire doors, kitchen units and worktops removed – presumably to assist with circulation around the house
- There was also an assortment of staple marks and other damage to walls and ceilings where cable/hoses had been installed. There were also scorch marks on doors where banks of transformers had been fixed
- Fitted wardrobes, desks and cupboards had been stripped from seven bedrooms, presumably to maximise available growing space
- Windows had been blacked out and floors covered in plastic sheeting.
- A significant amount of damage had also been caused by condensation as a result of the water/cultivation process
- This was a property owner policy with no applicable exclusions to the All Risks cover. The claim was accepted and dealt with

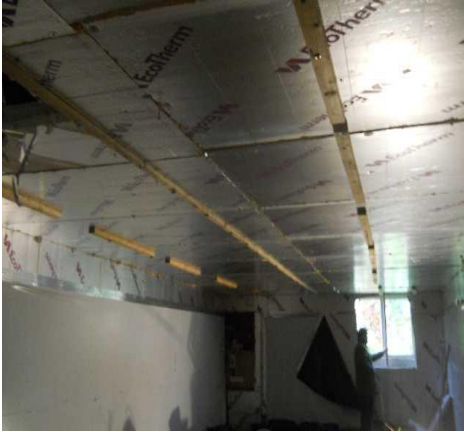
Room lined with insulation material

- The main house and various outbuildings had been used for storage and mixing of compost/elements necessary for cultivation
- A large number of rooms had been fitted out in order to provide insulated areas for cannabis growth/production. The cellar had been converted and equipped to dry the cannabis leaves

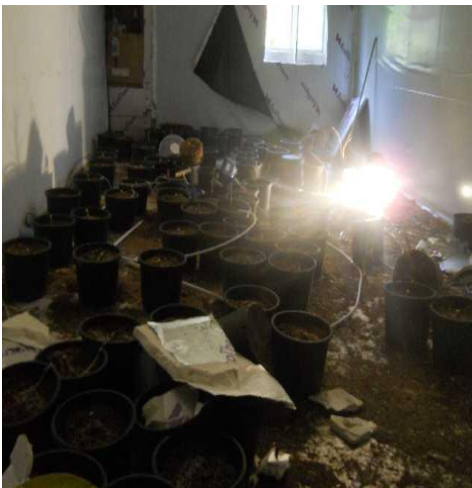
Evidence of cannabis production

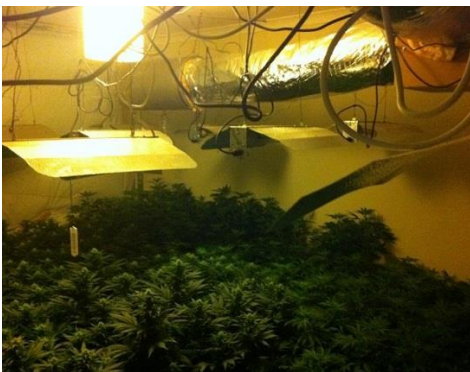
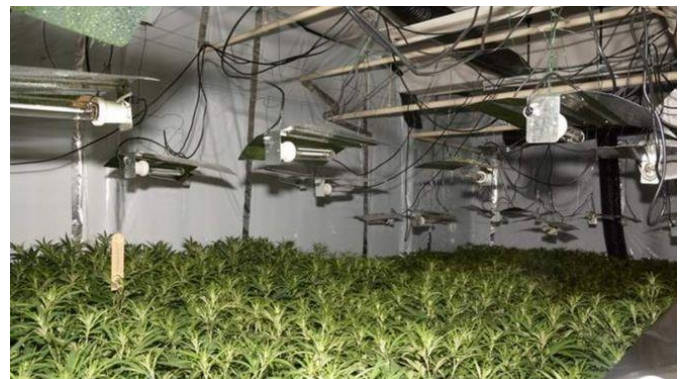
Lighting and ventilation equipment as found in large scale cannabis production

The theft of electricity is illegal, but this of course is not seen as a problem. The two crimes are almost always found side by side where cannabis growing is concerned. The reason is that the hidden nature of this process requires that warmth, fresh air and bright artificial sunlight are provided to ensure that the plants are able to grow. This is generally achieved by the use of multiple powerful lamps such as High Intensity Discharge lamps, which are more commonly used in high bay warehouses, arenas and stadiums. These lights have a high power requirement and they produce large amounts of heat, giving the added requirement for mechanical ventilation to dissipate the heat and provide a fresh supply of oxygen. It is therefore common to find large amounts of cabling feeding lighting, pumps and fans throughout the growing area. In large scale operations this can be professionally installed, but commonly, the workmanship leaves a lot to be desired.

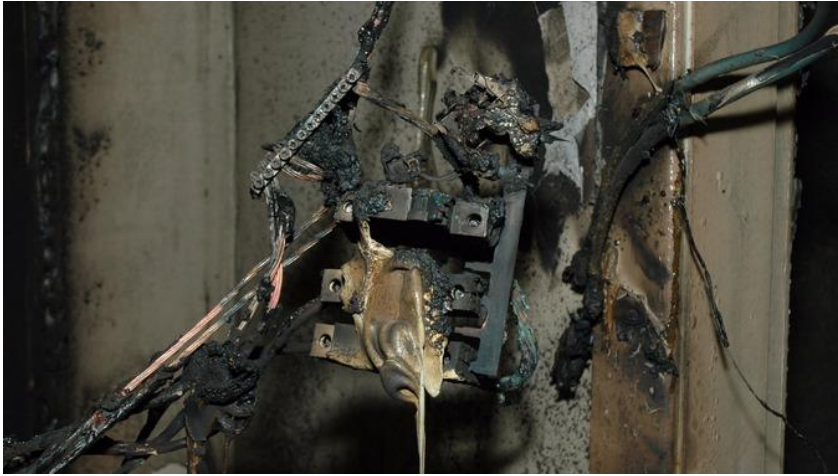
Typical damage from bypassing the meter

The majority of fires encountered within properties used for cannabis cultivation are related to the electrical supply. In addition to the sometimes dozens of junction boxes and connections required, the need to extract electricity without paying for it usually requires the electricity meter to be bypassed. These sometimes crude methods will involve poorly made electrical connections, which when being used to carry high levels of current, are likely to result in resistive heating and, ultimately, ignition. Working on live circuits to make these connections brings with it its own risks, the possibility of electrocution is also a reality and a number of deaths have been recorded.

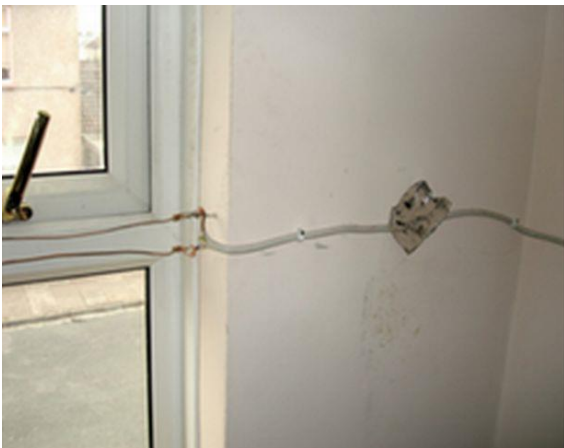
Windows wired to the mains

Such seizures have, in recent years, revealed the lengths growers will go to, to prevent discovery with numerous types of booby trap identified, designed to cause injury to anyone entering the growing area.

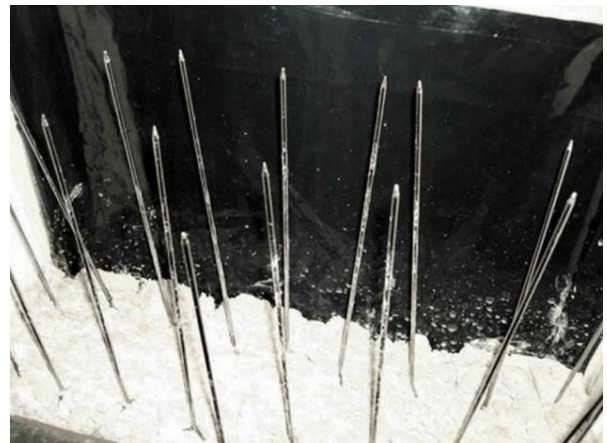
Spikes placed on windowsills
